**Docket No. 217 – Development and Management Plan Inspection**

Northeast Utilities Service Company Certificate of Environmental Compatibility and Public Need for the construction of a 345-kV electric transmission line and reconstruction of an existing 115-kV electric transmission line between Connecticut Light and Power Company's Plumtree Substation in Bethel, through the towns of Redding, Weston, and Wilton, and to the Norwalk Substation in Norwalk, Connecticut.

**Date:** June 7, 2006

**Location:** 115 kV Underground Route

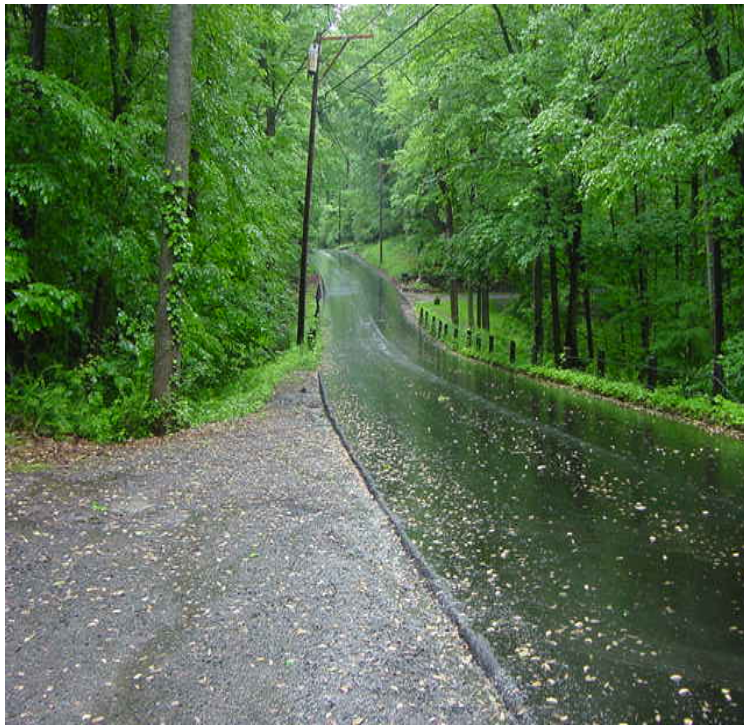
Photo on the left shows the recent new paving along Gallows Hill Rd. (Not shown: Some of the driveway entrances should be checked so they blend well) Photo on the right shows controls remaining at the storage area near Redding CC. 6/7/06

- <b>Hoyts Hill Transition Structure:</b> No further activities. 6/7/06	-See EC section. 6/7/06	-N/A
Rt. 107, Redding	- <b>Gallows Hill:</b> The roadway was repaved. 6/7/06	- Check driveways along the roadway to determine whether they "blend" well into the road. 6/7/06	- Needs attention
	-Work continues to bring remaining areas up to final grade. 6/7/06	- See EC section. 6/7/06	- N/A
Rt. 58, Bethel	- Work continues to bring the road to final grade. 6/7/06	-See EC section. 6/7/06	- N/A
Broad Street/ROW, Norwalk	-Work to repave the roadway and restore asphalt berms was complete and the roadway looks good. 6/7/06	-None at this time. 6/7/06	-N/A

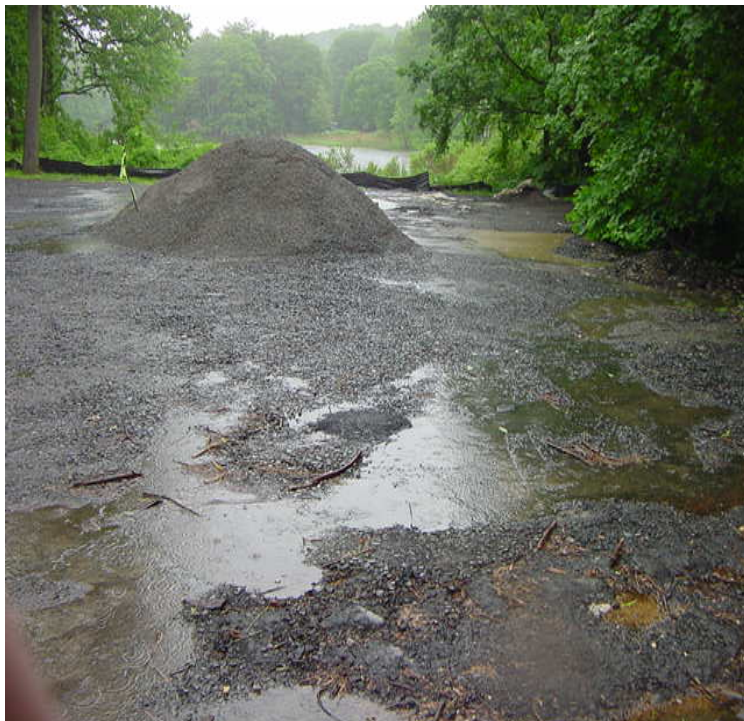
Photo on the left shows a small process pile in place at the Putnam Park storage area. An area along the silt fence here was pushed over when removing or placing the pile. Photo on the right shows Broad St in Norwalk, which was recently repaved. 6/7/06

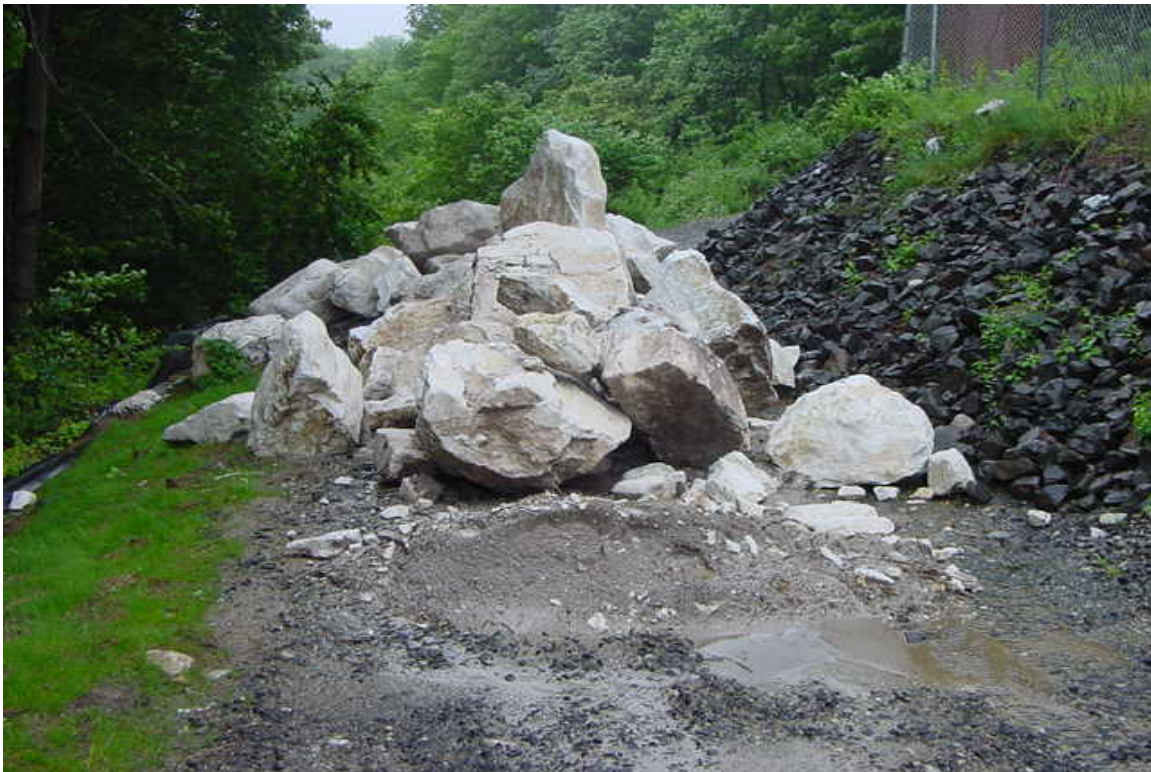
Photo shows where boulders were being piled along the southern portion of the ROW at Bethel Ed Park. These will be installed along the soccer field slope for reinforcement. 6/7/06

Areas of Inspection	Observation	Recommended Action	Corrective Action
Active Work	- <b>Bethel Educational Park:</b> - Boulders were delivered to the southern portion of the ROW. 6/7/06	-These will be installed to help reinforce the slope at the soccer field. Also, see EC section. 6/7/06	-N/A

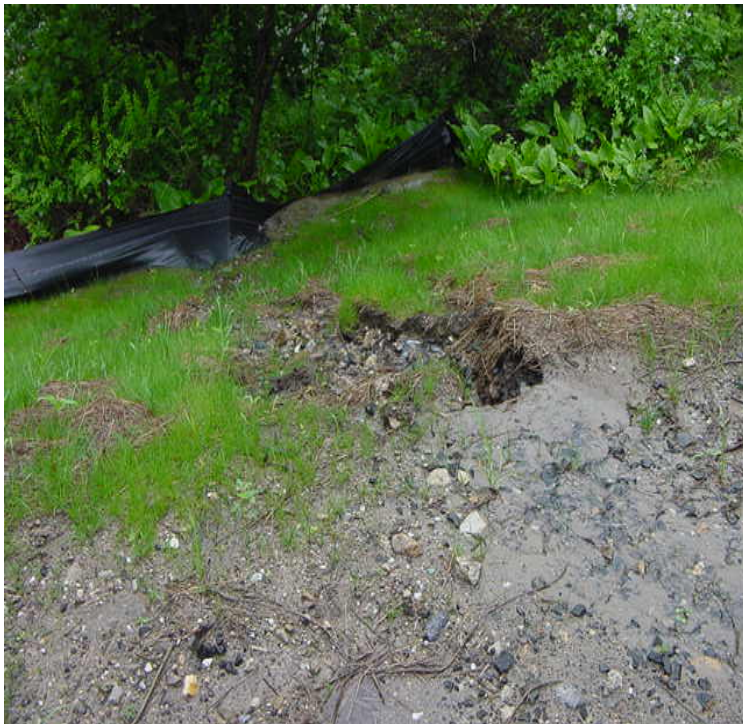
Photo on the left shows washouts along the southern portion of the ROW near the south tower. Sediment is overtopping the fence in several locations. Photo on the right shows further restoration in the area of the Bethel Middle School. 6/7/06
